序号	报告编号	发布日期	结论	影像资料
130	GX-B1310/21-2-23376	2023. 12. 6	符合标准要求。

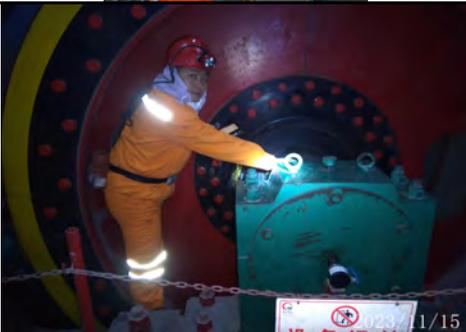
134	GX-B1310/21-2-23380	2023. 12. 6	符合标准要求。

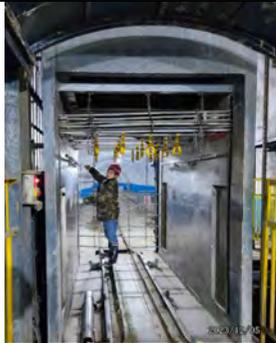
148	GX-B1380/20-2-23012	2023. 12. 11	所检项目合格。

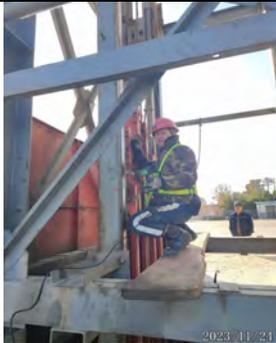
154	GX-B1427/21-2-23391	2023. 12. 10	符合标准要求。

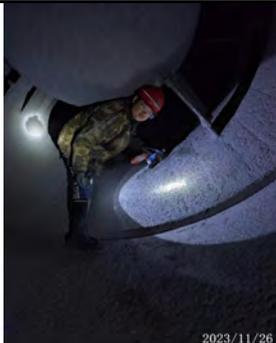
<p>2023/11/27</p>
159	GX-B1428/21-2-23394	2023. 12. 10	无缺陷迹痕显示。

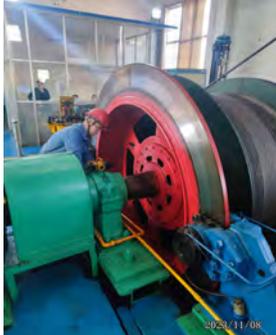
176	GX-B1310/21-2-23366	2023. 12. 7	符合标准要求。

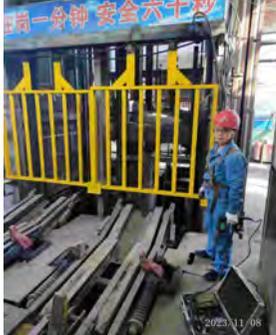
177	GX-B1427/21-2-23366	2023. 12. 7	符合标准要求。
